# **CROOKED LAKE LAKE CLASSIFICATION REPORT**

**Presented by Reesa Evans, CLM, Lake Specialist  
P.O. Box 287, Friendship, WI 53934**

**MARCH 2008**

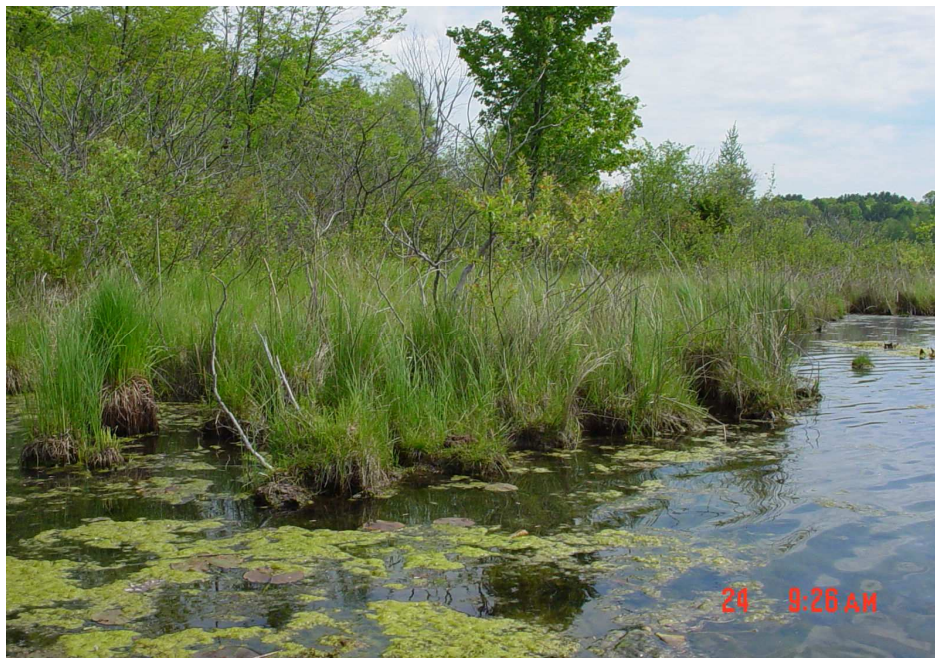
**Figure 8: Crooked Lake shore wetland**

The photo in Figure 8 shows one of the wetlands along the shore of Crooked Lake. Looking at the map of wetlands directly around Crooked Lake (see Figure 9) makes it evident how important wetlands are to Crooked Lake...more than 1/3 of the lake has wetlands at or near the shore that serve as filters and trappers that help keep the lake as clean as it is. It is essential to preserve these wetlands for the health of Crooked Lake.

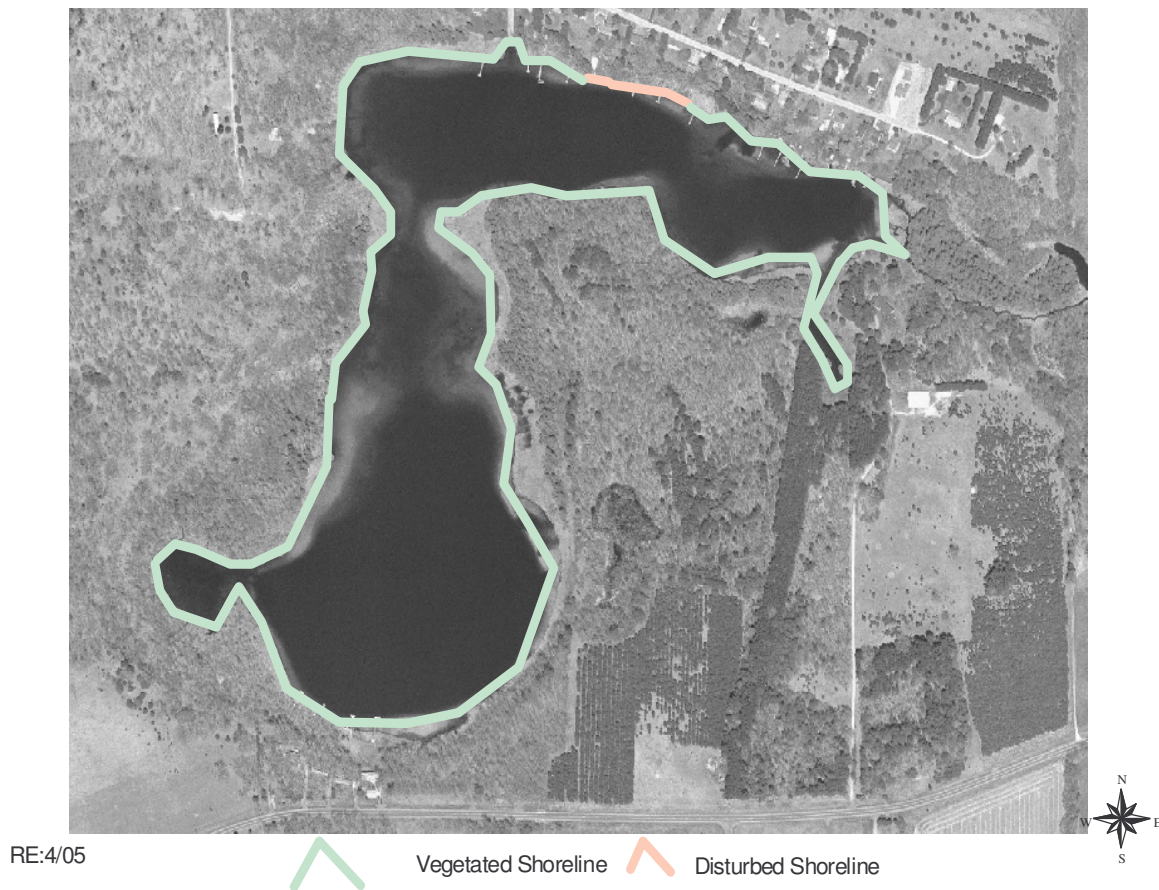
**Figure 11: Shoreline of Crooked Lake (2004)**

The Adams County Land & Water Conservation Department conducted a survey of the Crooked Lake shoreline in 2004. Shore types were categorized as “armored” and “vegetated”. “Vegetated” shores encompassed both native vegetation of any type and mowed lawns. 93% of Crooked Lake’s shoreline is naturally vegetated. The remaining 6% is mowed lawn.

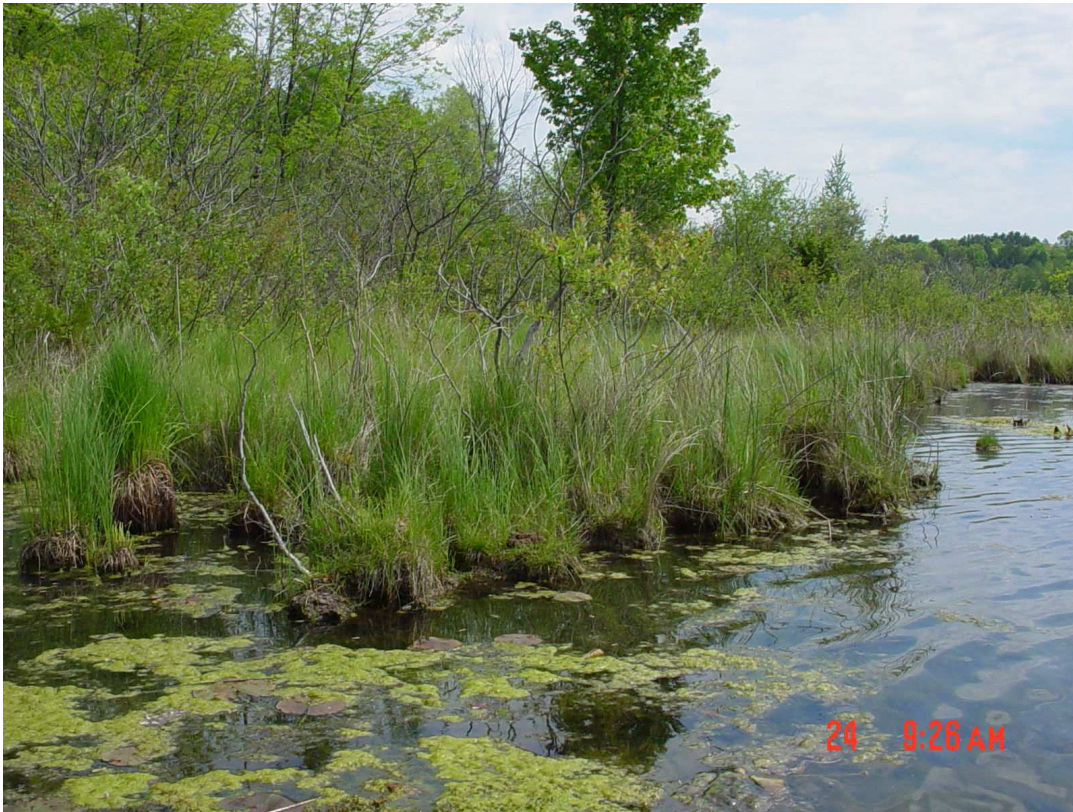
**Figure 46:  
Sedge  
Meadow in  
CR1—  
Point A on  
map**

This area extends along approximately 4200 feet of the shoreline. Sediment includes marl, muck, peat, sand, silt and mixtures thereof. 24% of the shore is wooded; 27% has shrubs; 49% is native herbaceous cover. Several types of wetlands are found along this shoreline: shallow marsh; deep marsh; sedge meadow; shrub-carr; and tamarack bog. Large woody cover is common for habitat. With virtually no human disturbance along this shoreline, the area has natural scenic beauty.

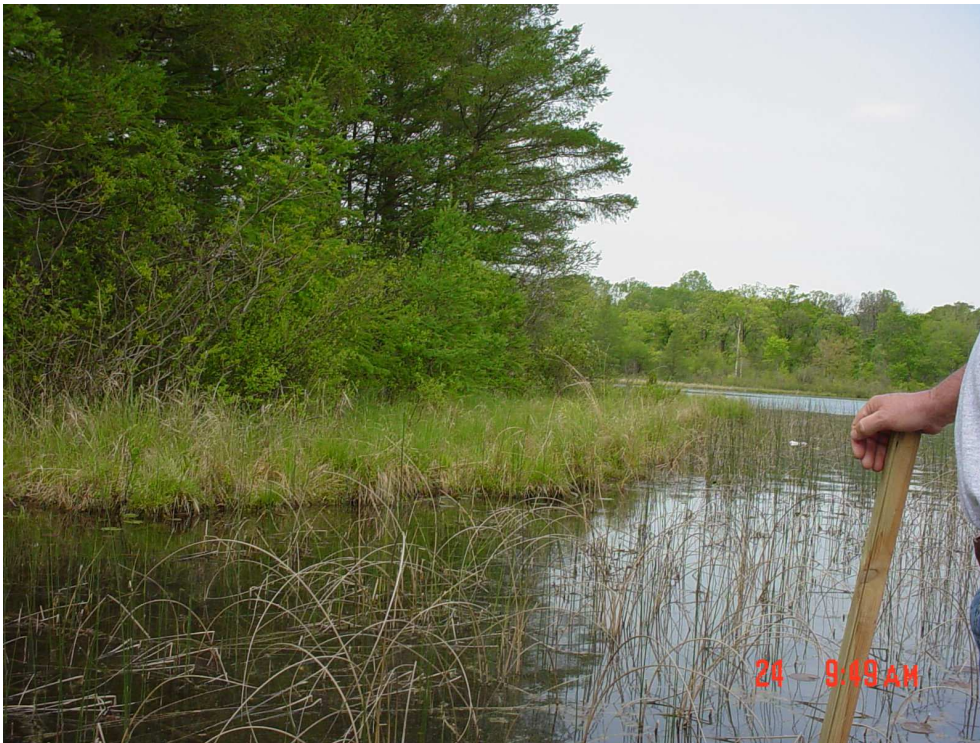
**Figure 48:**  
Sedge Meadow  
in CR2—See  
Point C on map

This area extends along approximately 2900 feet of the shoreline. Sediment includes marl, peat, silt and mixtures thereof. 40% of the shore is wooded; 10% has shrubs; 50% is native herbaceous cover. Sedge meadow and tamarack bog wetlands are found along this shoreline. Large woody cover is abundant for habitat. With little human disturbance along this shoreline, the area is has natural scenic beauty.

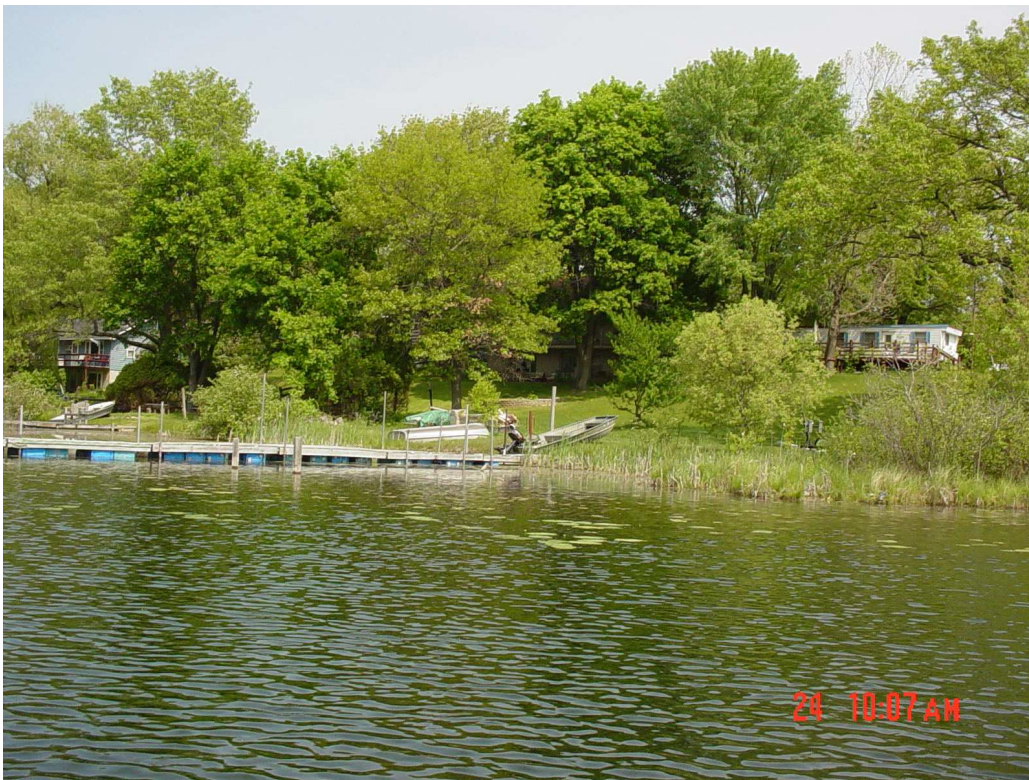
**Figure 50:  
Some of CR3  
Developed  
Areas—See  
Point E on  
map**

This area extends along approximately 3300 feet of the shoreline. Sediment includes marl, muck, peat, sand, silt and mixtures thereof. 7% of the shore is wooded; 20% has shrubs; 57% is native herbaceous cover—the remaining 16% is cultivated lawn. This sensitive area includes the most developed area of Crooked Lake. However, there are areas of wetlands: shallow marsh; sedge meadow; conifer swamp. Large woody cover is present, but not as much as in the other two sensitive areas. Scenic beauty in part of the area is lessened due to the human development. Most development in this area has been carried out so as to preserve habitat and minimize negative human impact. Several spawning beds were observed in this area.
